Fixing the E38 Power Sun Screen

Hugh Sparks

Version 1.0, March 28, 2003

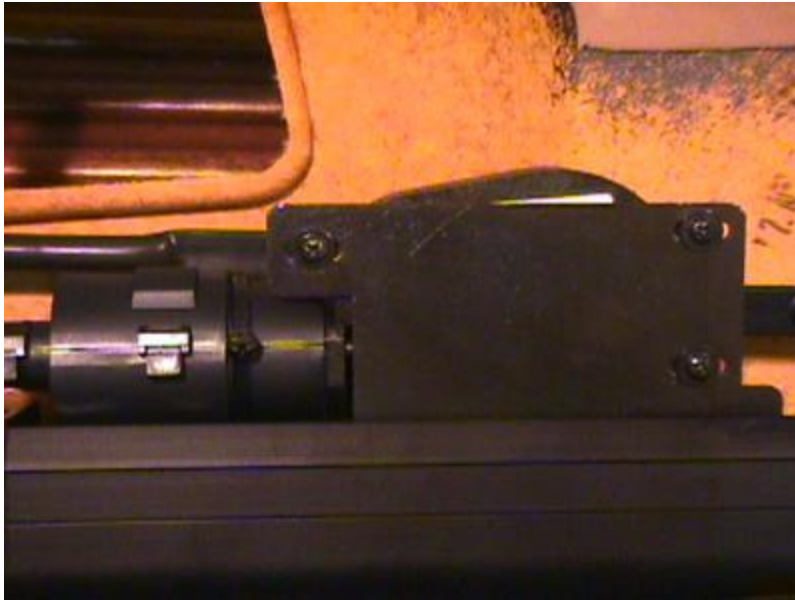
Closer view of motor and gearbox in place

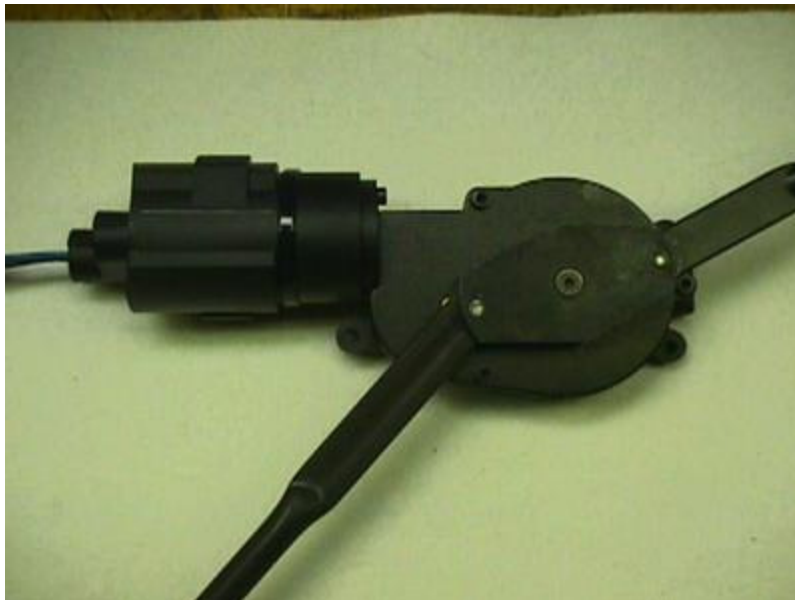
Motor and gear box, crank plate side

Remove the crank plate screw with a 2.5mm Allen wrench and pry off the plate.

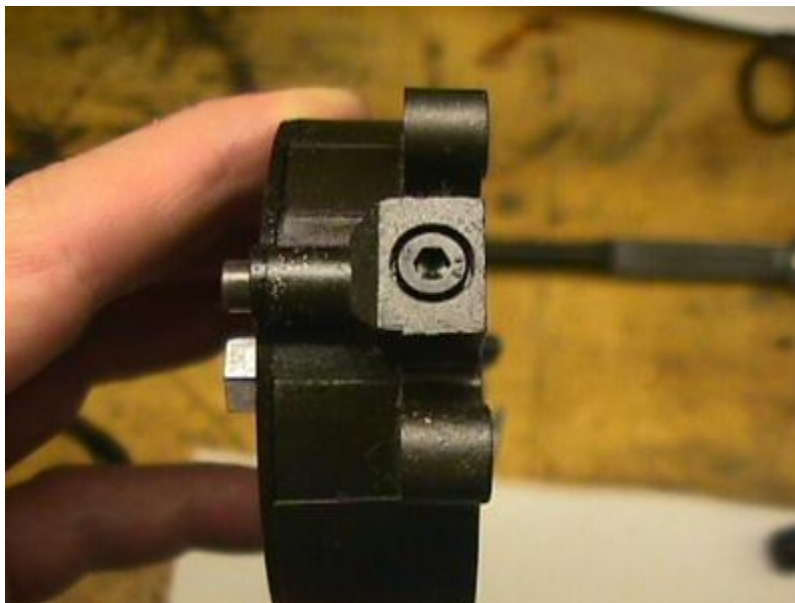
The stop screw

Run the gears to an intermediate position between the stops. Now remove the stop screw on the lower right edge.

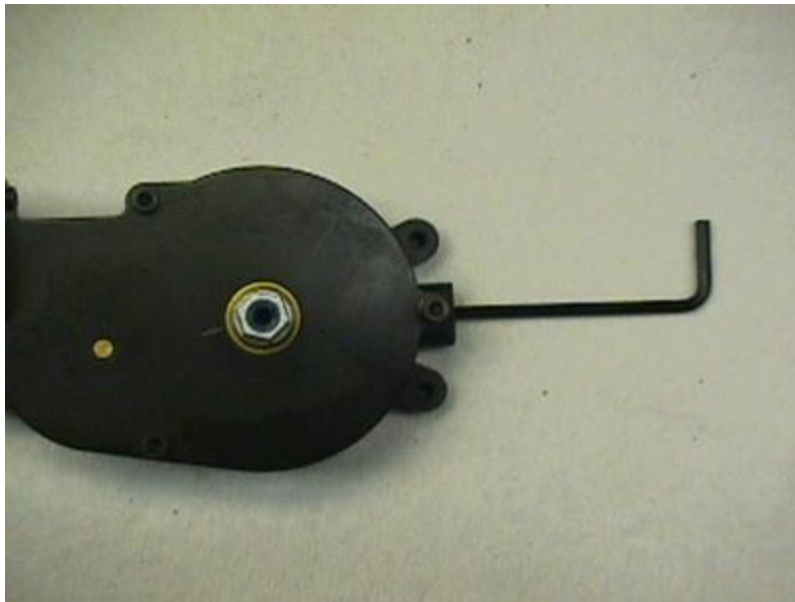
Location of stop screw

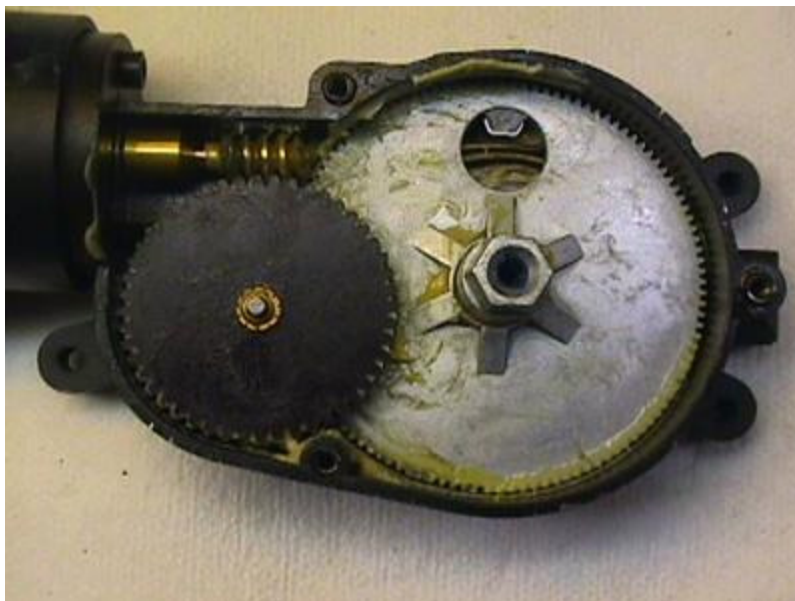
Gear box opened

Remove the 3 2.5mm Allen screws that attach the lid. Pry up the lid with a thin blade, working your way around the edge. The lid has to go straight up because of the big brass bearing for the hex hub. Look inside to the right of the hex hub and you will see a smaller shaft and gear. Hold this down in the box with a screwdriver as you pry off the lid. If for some reason, you failed to unload the spring, keeping this gear in place will avoid a run-away.

If all is well, the gears will be loose in the case and you can remove them.

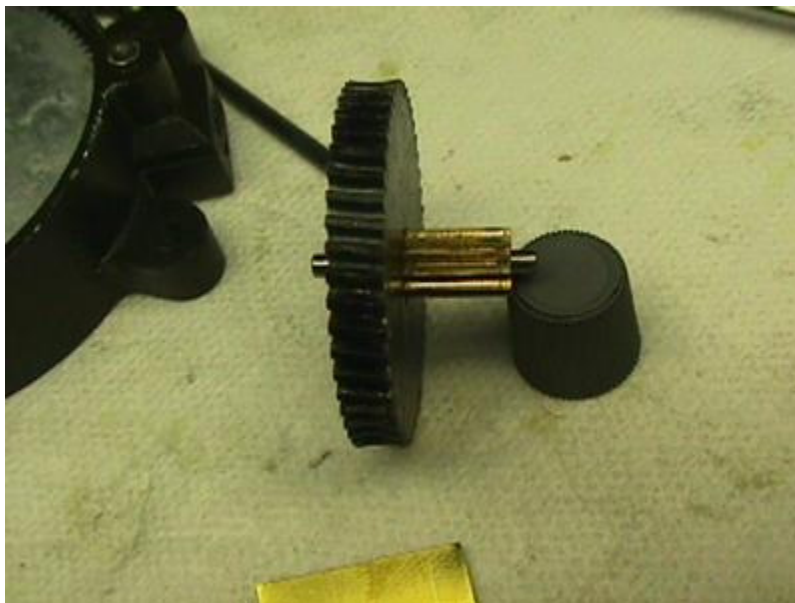
The frequency of the clacking was about 4 Hz. I realized this was much too fast for the brass pinion to be popping in and out of the big pot-metal gear. The noise had to be due to the worm popping out of mesh with the fiber gear.

Fibre worm wheel and brass pinion

I inspected this gear again and could just make out a small region of slight wear. Could this be enough to disengage the worm under load? If so, the depthing of the worm must be much too shallow. I measured the pitch diameter of the worm and fiber gear and computed the correct center distance. (Yes, it's all in *Machinery's Handbook*.) Comparing this result to the actual center distance between motor and gear, I found that the mesh was indeed too shallow by almost 0.5mm.

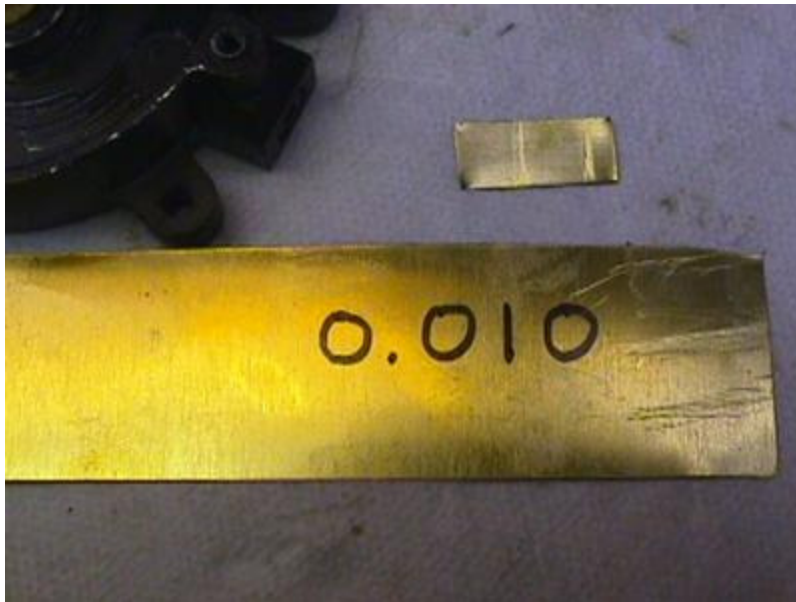
Shim stock cutout

Since the gears were still in good condition, I decided to try moving the motor to obtain a better depth. This turned out to be very easy: I simply put a strip of 0.010" brass shim under the lower edge of the motor. This offset the worm by just the right amount to get a good mesh.

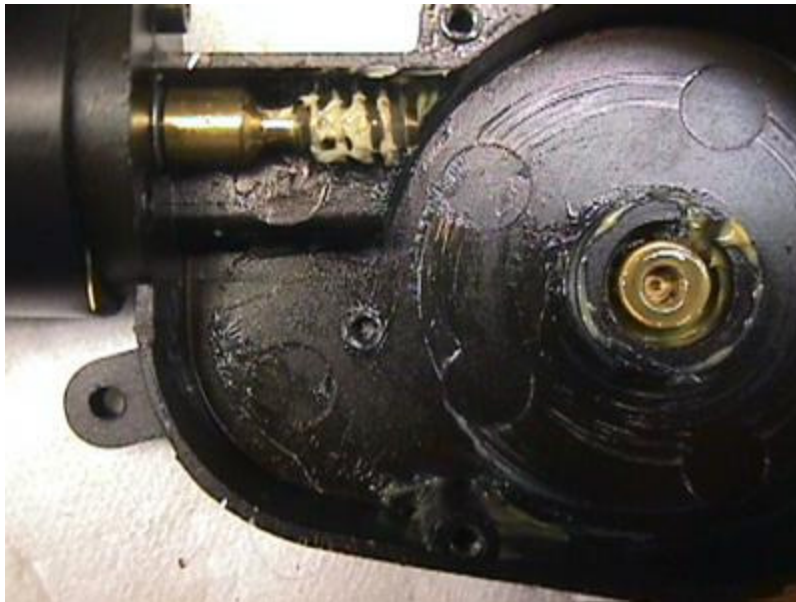
Shim installed on lower edge of motor

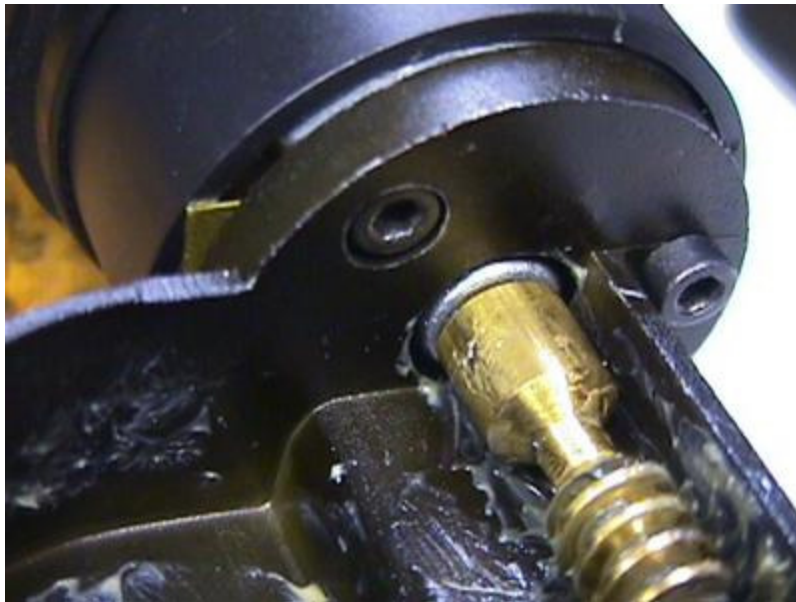
Front view of shim

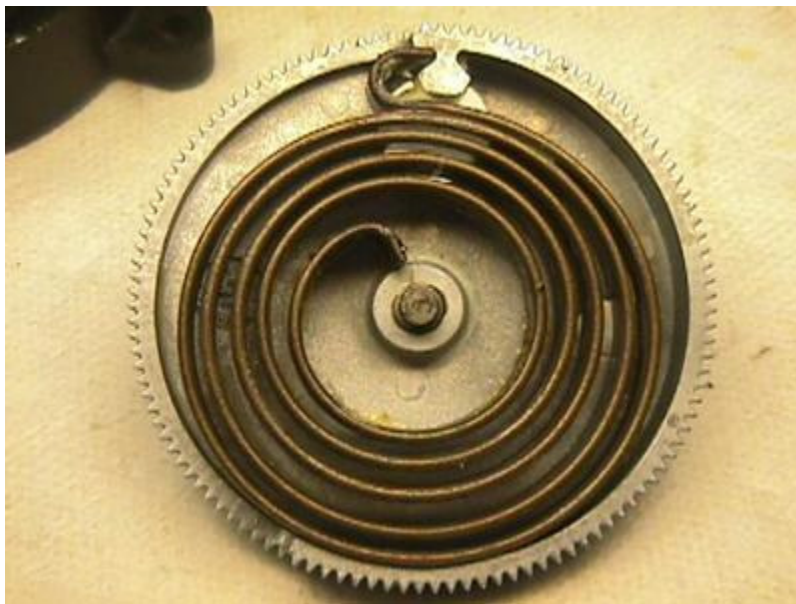
Main spring installed

Install the main spring as shown below.

Put the box together and tighten down the lid screws. Remove the stop screw if you have reinstalled it for testing. Rotate clockwise under power just enough to line up your scratch marks. The hub should only have to turn through one or two facets to realign the marks. Now rotate clockwise one full turn to get the proper load on the spring. The hub now wants to unwind counter-clockwise.

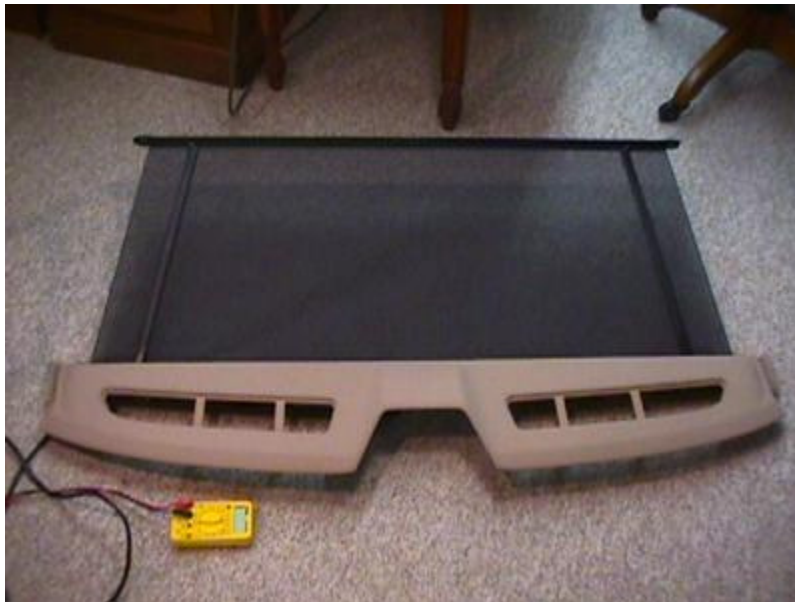
Testing the screen

Now you're ready to test! Put the whole assembly on the floor with the motor on the bottom side. (As it would be in the car.) Apply power to raise and lower the screen. Woopee.
